**National
Transportation
Safety Board**

Helicopter Case Studies

Case Study 1

- MD Helicopters 369D
- One Rolls-Royce 250-C20B
- Near Oso, WA
- July 22, 2014
- Injuries: 1 serious
- NTSB Case No. WPR14LA308

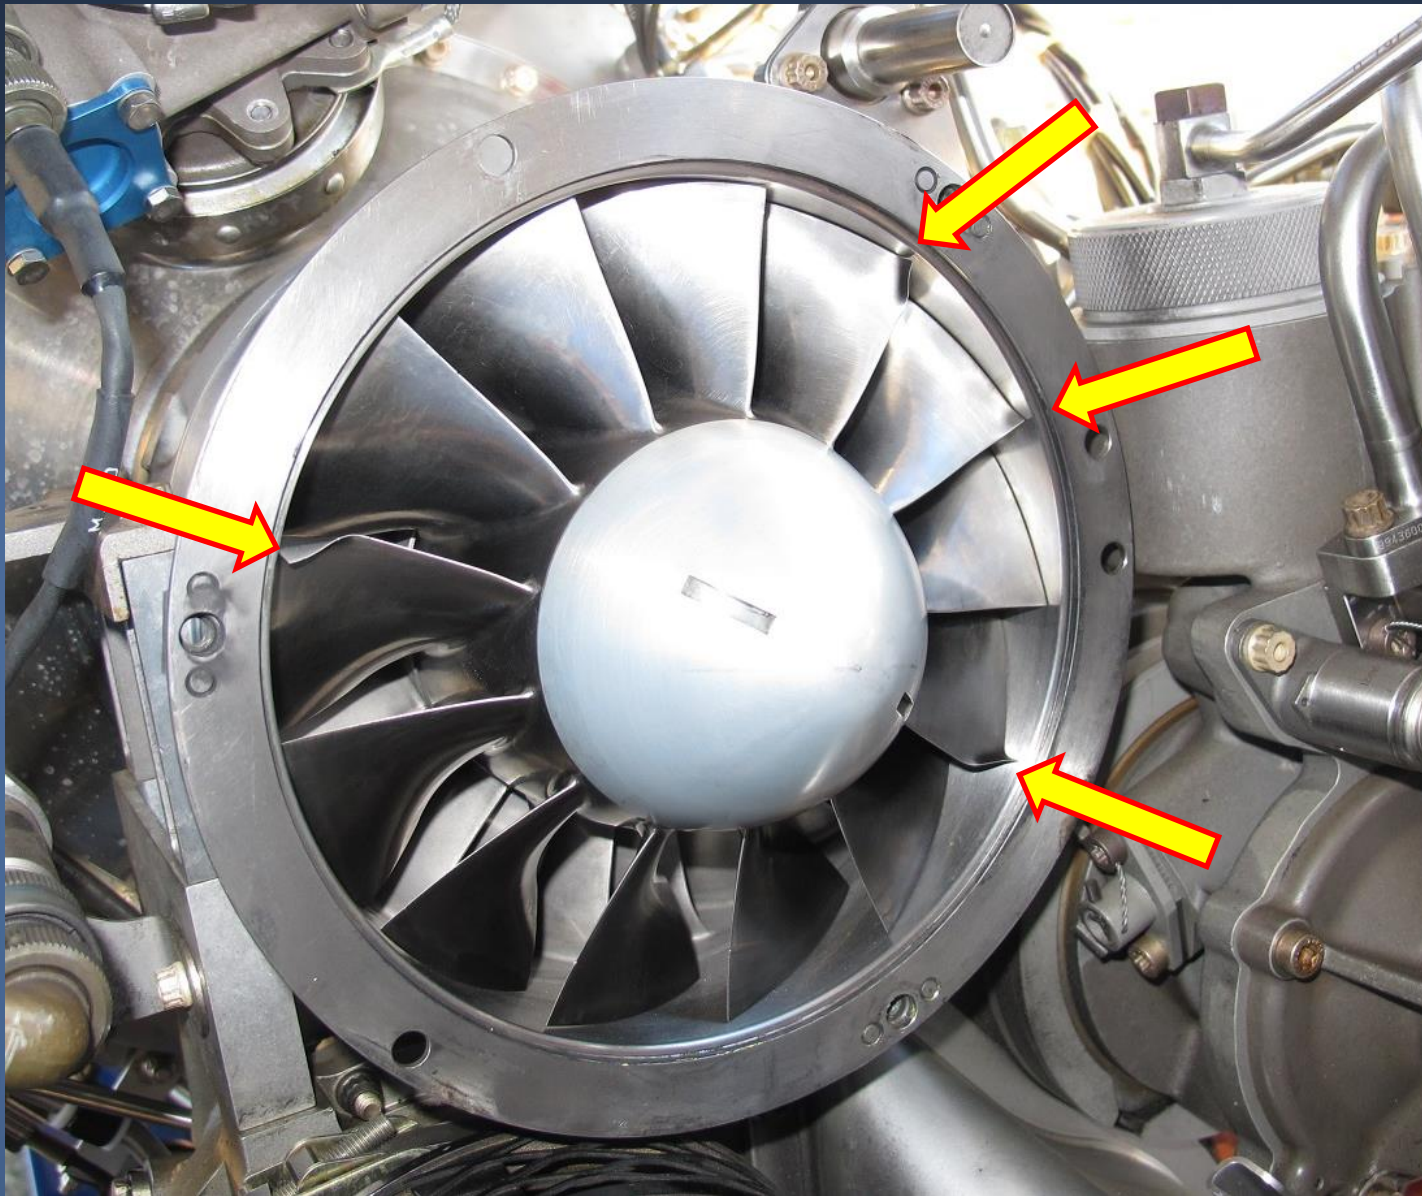
- Engine fuel, oil, and electrical connections remained intact.
- Fuel sample tested negative for the presence of water.
- Removal of air intake duct revealed four axial compressor blades exhibited deformation, in the direction opposite of normal rotation, on outboard tips of their leading edges.
 - Consistent with “soft body” (e.g. birds, plastic, ice) FOD damage.

- The loss of engine power due to ice ingestion. Contributing to the accident was maintenance personnel's delayed decision to install the helicopter's engine inlet cover until after the engine had been exposed to moisture and freezing temperatures and their inadequate daily preflight/airworthiness checks, which did not detect the ice formation.

- FAA re-released an SAIB reminding operators of precautions to take during cold weather operations.
- Helicopter and engine manufacturers released similar safety notices to operators.
- The operator released an internal notice on engine operations in cold weather conditions.
